Productivity First-Round Winner
Innovations Challenge

April 2016

Prepared by Transportation Planning
Missouri Department of Transportation

Pavon Pressure Sprayer

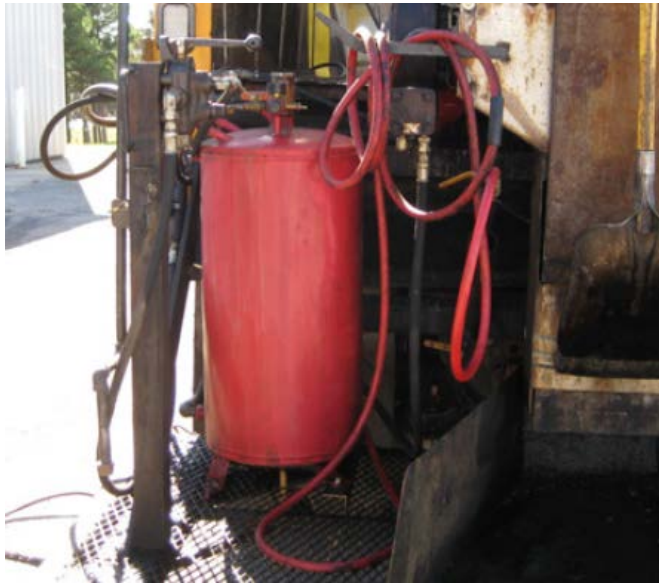
Pavon is a material similar to tack oil that is used to patch potholes. Traditionally, Pavon is dumped from a bucket into potholes before applying the patching material. Pavon is a very sticky, thick material that comes in five gallon buckets. By utilizing the Pavon Pressure Sprayer, the material can be applied using a different method. With the sprayer, Pavon is cut with 50 percent water. Cutting tack oils is a common procedure and has not been found to impact the durability in the past. This allows the Pavon to be sprayed into the potholes rather than applied as a thick, sticky liquid. The change in application results in a quicker, easier process and less wasted material.

This sprayer saves money because the Pavon is cut by 50 percent with water, and by spraying it on the road instead of dumping it from a bucket, less product is wasted. It saves time and simplifies work because it can spray holes and cover the entire hole with one quick spray. It is safer because crew members don't spend as much time on the road patching the hole. In addition, back injuries can be reduced since crew members do not have to pick up a heavy bucket and bend over to pour the material.
