Stainless Steel Tow Plow Lines

Description and Benefit

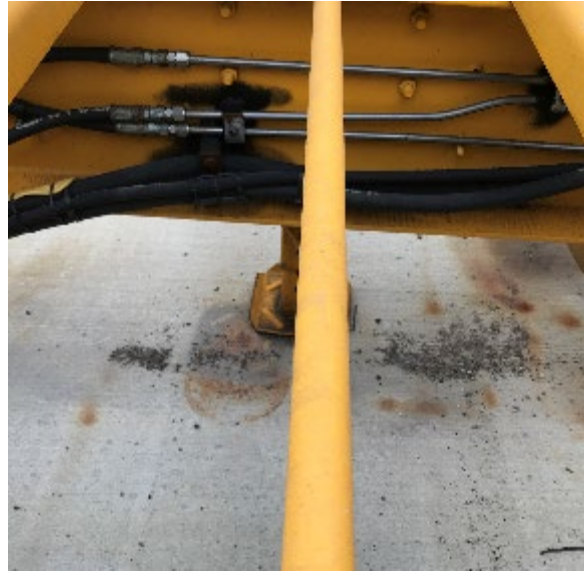
For the tow plow, we have introduced stainless steel lines in place of the old hydraulic hoses and steel fittings under the spreader bed for the steering and lift cylinders. The reason for this innovation is to avoid costly and preventable repairs. Another reason for the innovation was to eliminate down time of the tow plow when it is being used during a snow event. In the past, when there was a blown hydraulic line, the tow plow was down until the end of the storm because there is no possible way to get under the spreader bed with all the snow packed in the frame. The regular hydraulic hoses would quickly wear out or become damaged and it was very difficult to change the hoses or to make quick repairs. By using the stainless-steel hydraulic lines, there is minimal wear and if something does need to be repaired, we can repair smaller sections instead of changing out the whole hydraulic hose.
