## Rear Rock Guard

### Description and Benefit

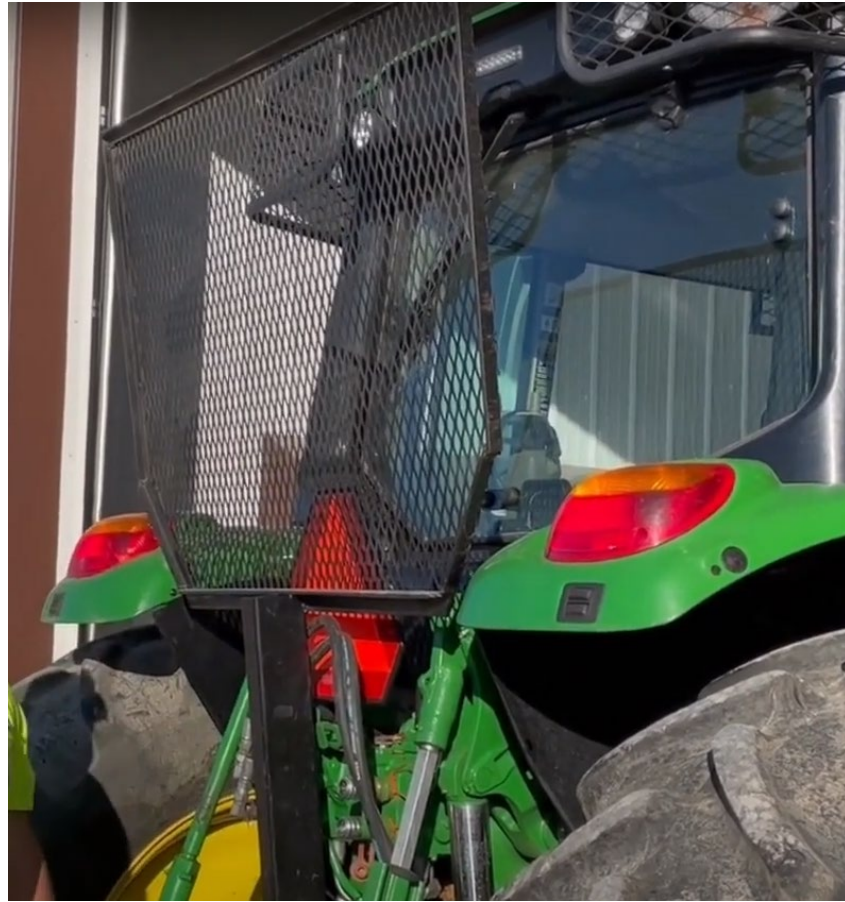
When mowing the right of way, foreign objects can sometimes hit the back glass causing it to break. The glass then ends up in the cab with the operator. This is a safety issue for the operator as well as an expense to MoDOT and down time till we can get another glass. The old rock guard was mounted to the lift arms and did not always cover the rear glass while going up and down slopes. With this style it is always protected and only has one mounting point instead of two.
